**THE LICE EARTHQUAKE IN SOUTHEASTERN TURKEY:  
A GEOGRAPHY OF THE DISASTER**

**CAPTAIN WILLIAM A. MITCHELL**

**DECEMBER 1976**

**FINAL REPORT**

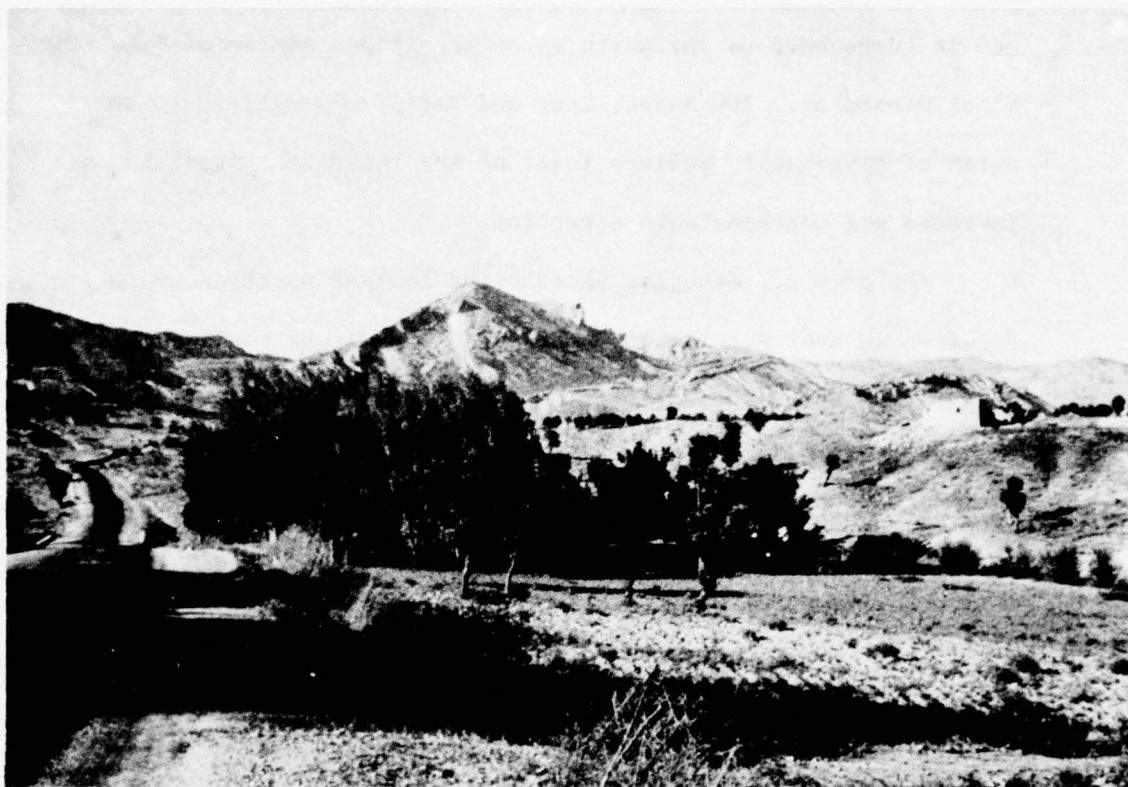
Figure 6. Approaching Lice from the Southwest on the newly asphalted Diyarbakır-Lice road. Note the thrust fault system in the center of the picture.

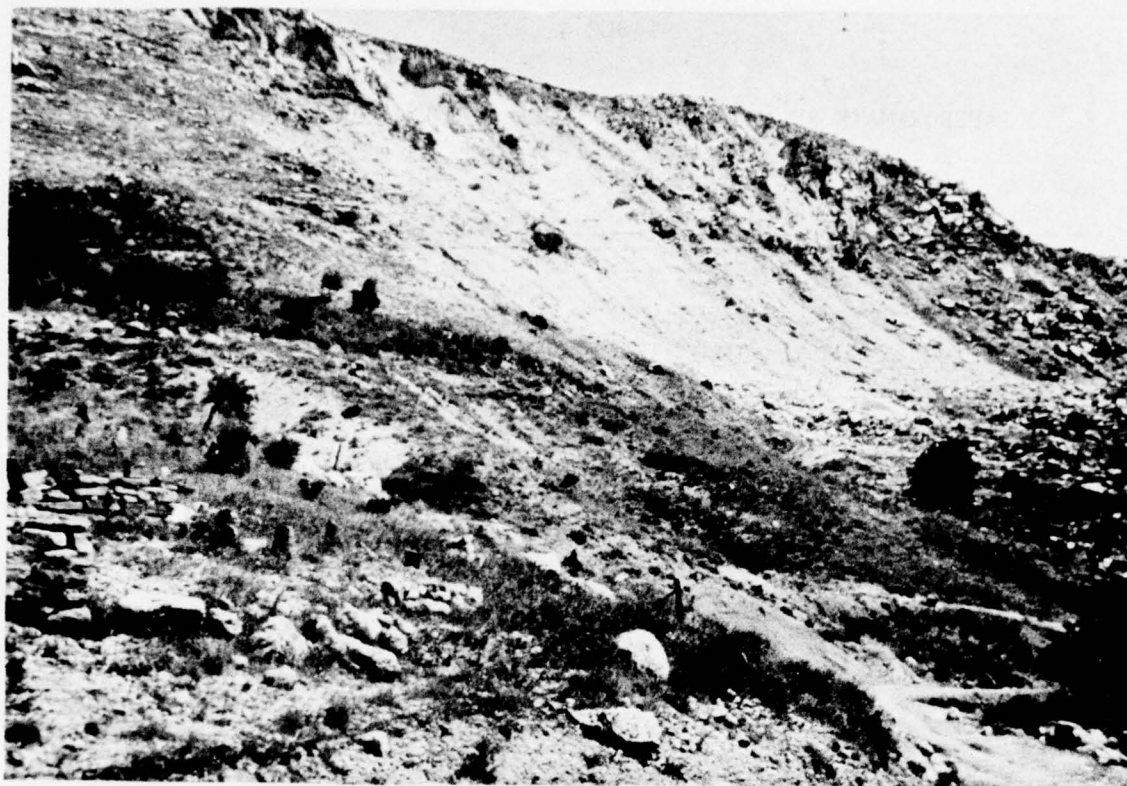
Figure 10. Massive limestone rock slides occurred above Lice. This slide was on the east side of Lice. The cemetery is shown in the bottom left corner.

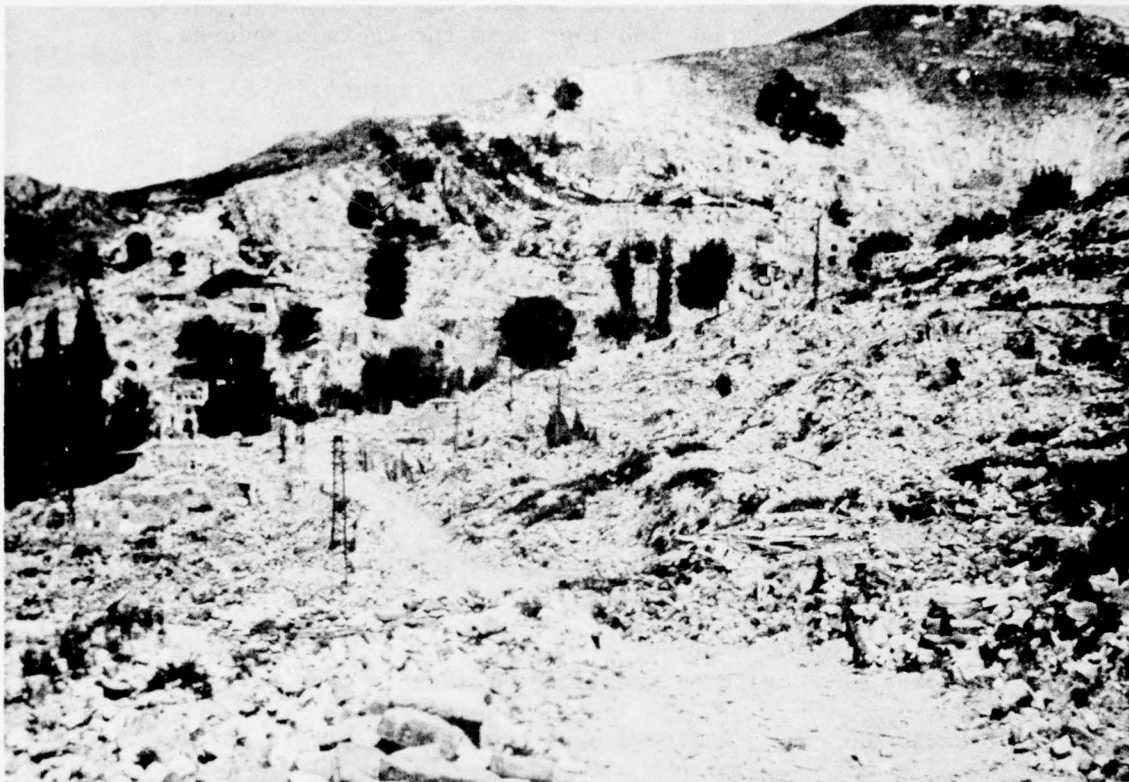
Figure 15. Looking westward from the east side of Lice. The row of trees in the center of the picture are along the Cami valley which divided the town. Rock slides are noticeable at the top of the picture.

collapsed tons of stones, mud, and logs from the roofs of houses, onto the people inside (Figures 15, 16, A1, A2, A3).<sup>21</sup>

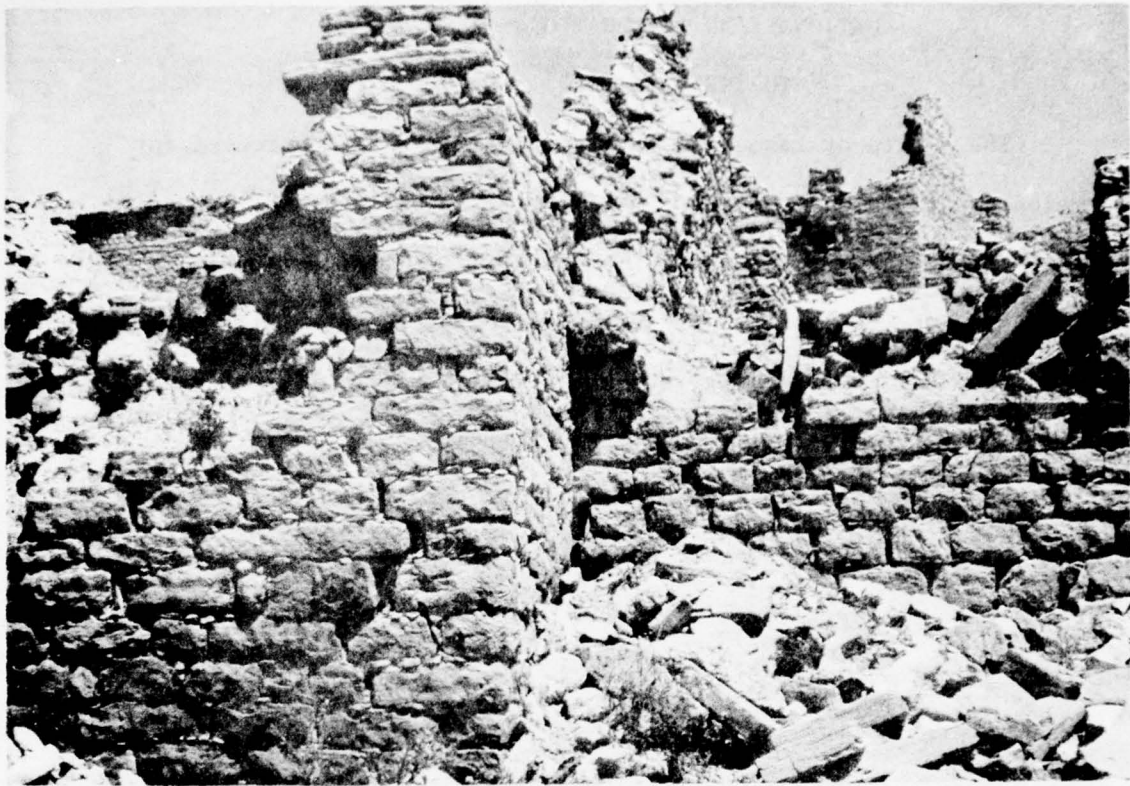
Figure 16. Massive destruction in upper Lice.

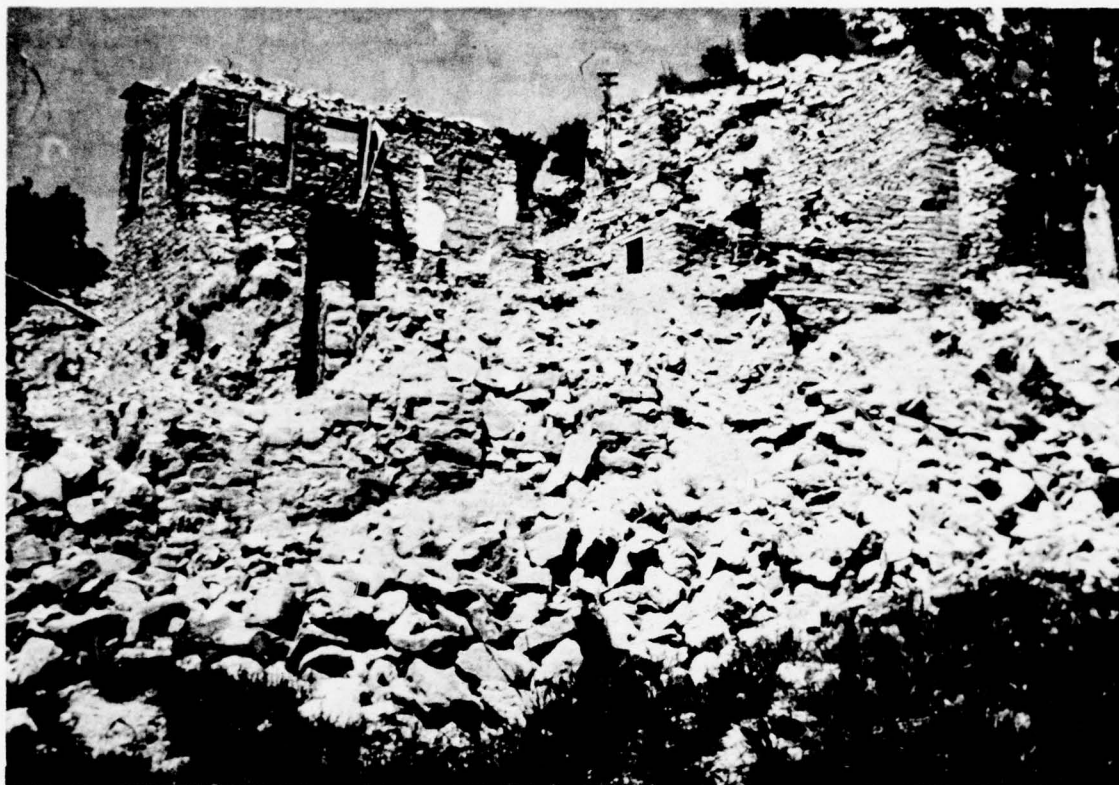
Figure A1. Typical uncemented adobe construction. The few logs and poles which were used for ceiling supports have been removed.

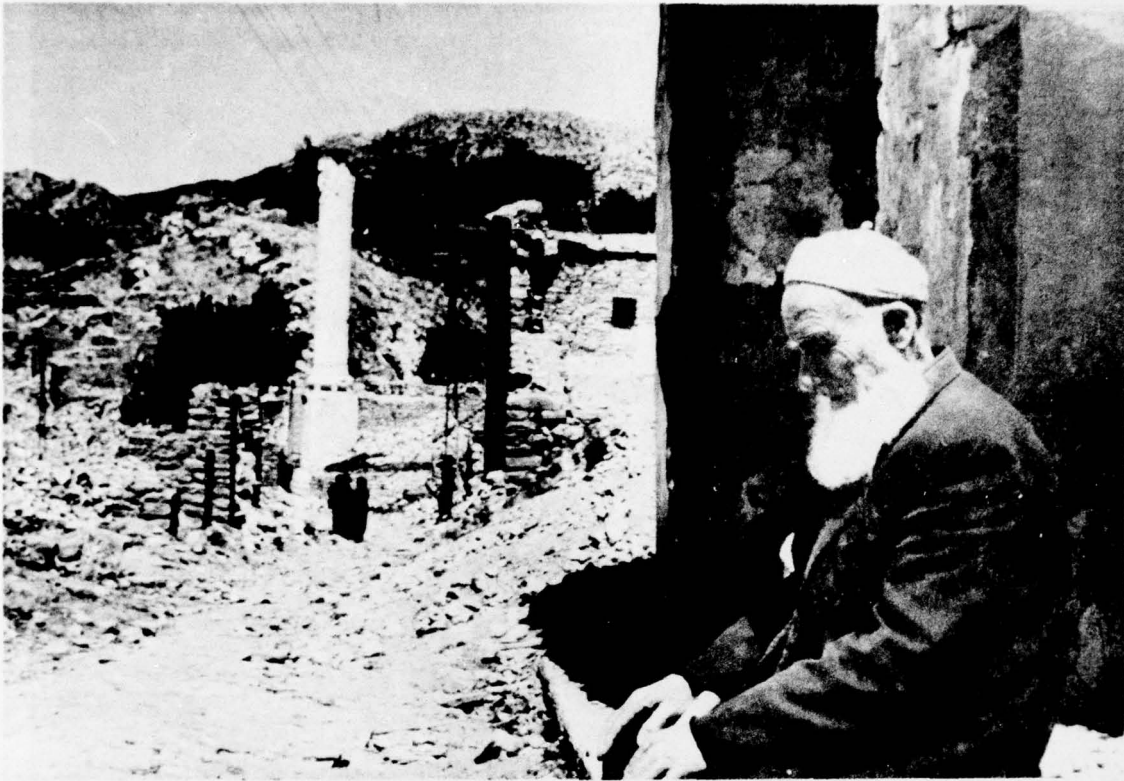
Figure A2. Although no one lives in old Lice, former residents still walk through the ruins and visit their old homesites. Note the damaged minaret in the center.

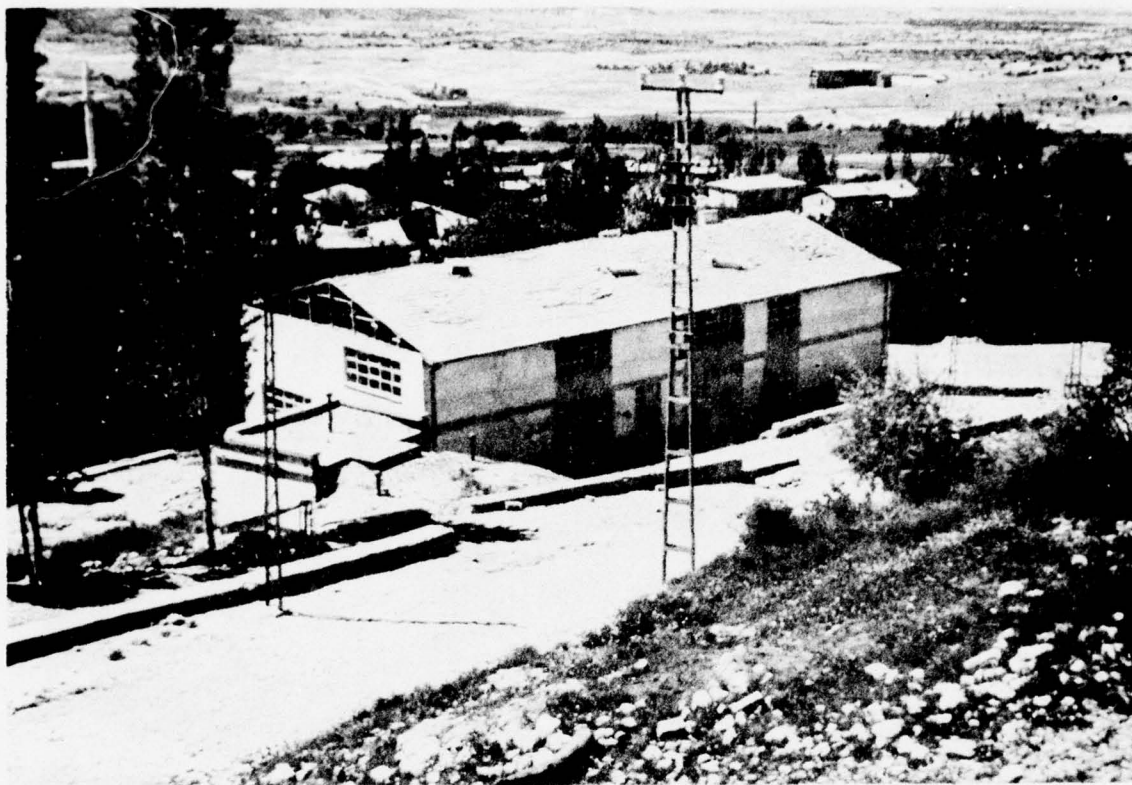
Figure A5. A completely ruined high school building in Lice. Notice the sunken tile roof. A new school has been constructed in the new town.

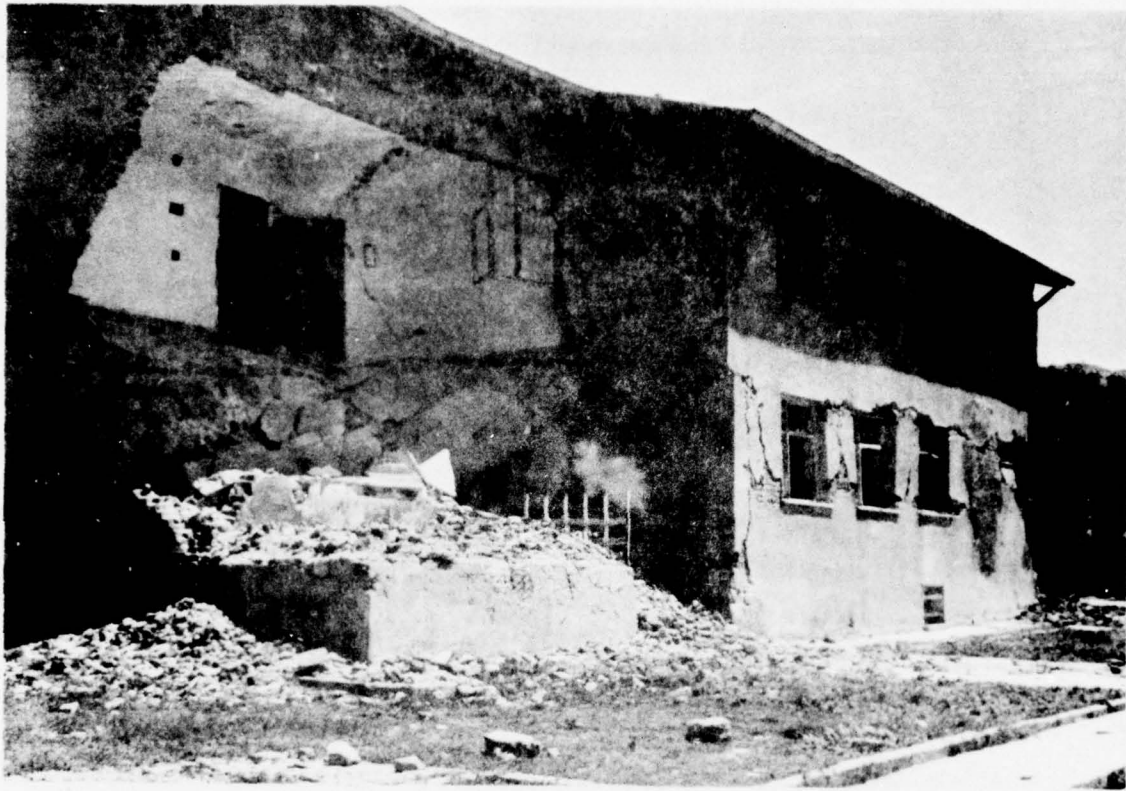
Figure A6. The completely destroyed police building in Lice.

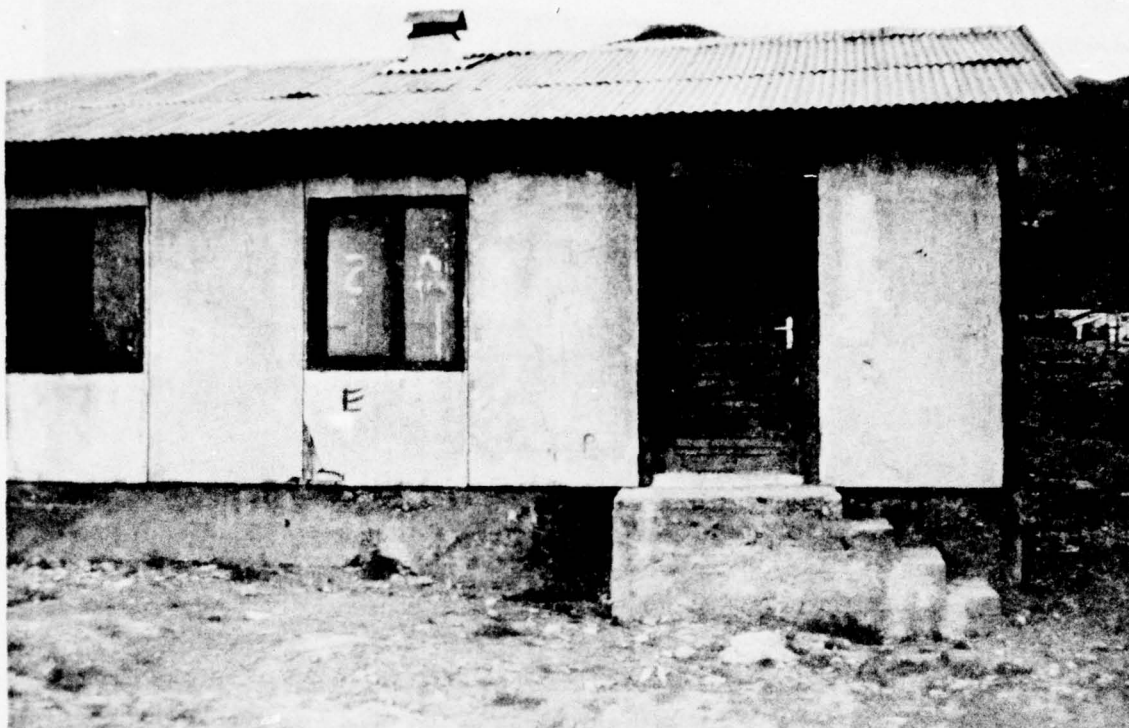
Figure A13. A close up of a new duplex. The house appears much older than its nine months. The concrete foundation has a large hole, the prefabricated wall has been punctured and the corrugated roof is loosely attached in several places.

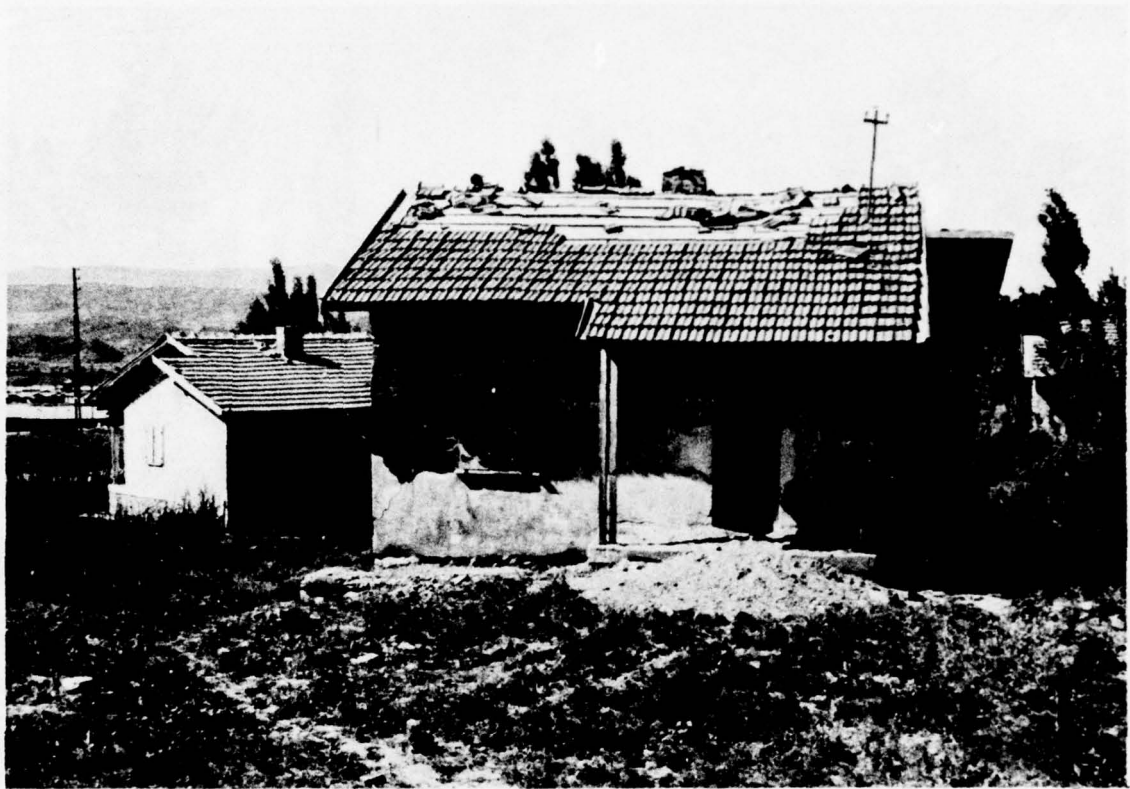
Figure A21. One of the earthquake resistant houses built in Lice by the Ministry of Reconstruction and Resettlement several years ago after a rockslide. Note the dislocated tiles on the roof and the fallen plaster.

remained occupied after the earthquake (Figures A21 and A22). Some houses had fallen and cracked plaster, and dislocated roof tiles, but none had severe structural damage.

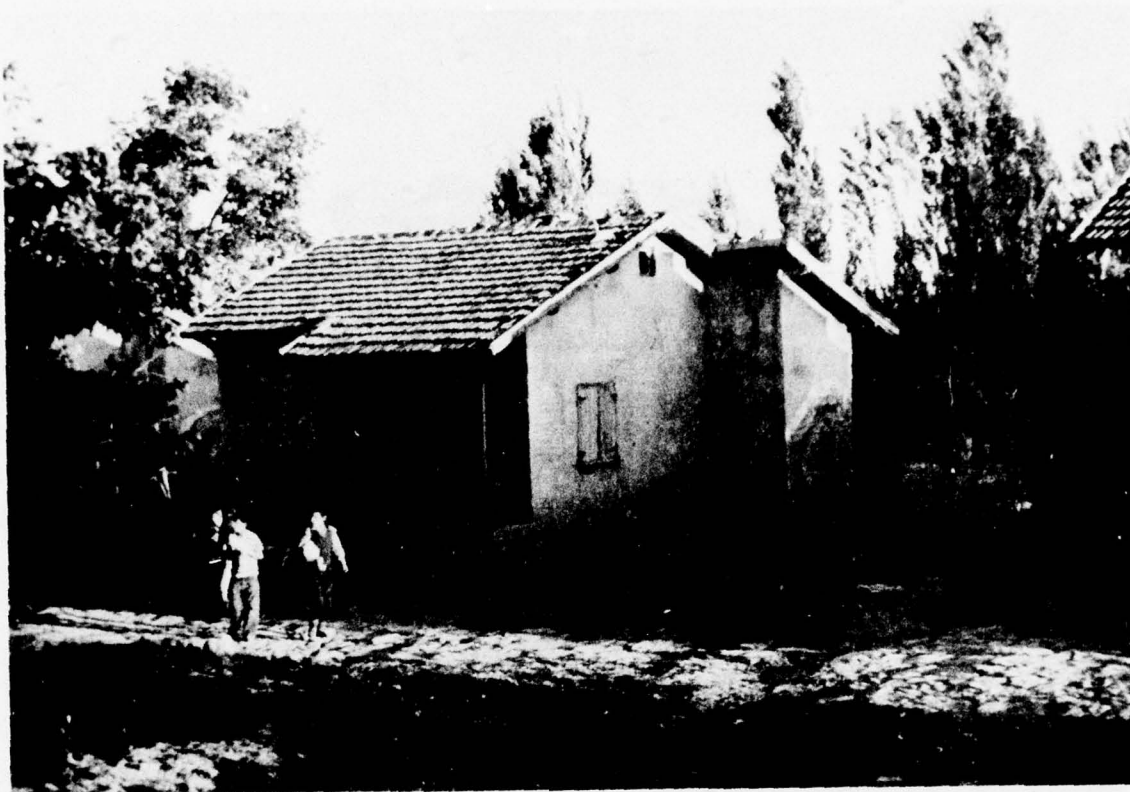
Figure A22. Another of the 150 houses built after the rockslide several years ago.

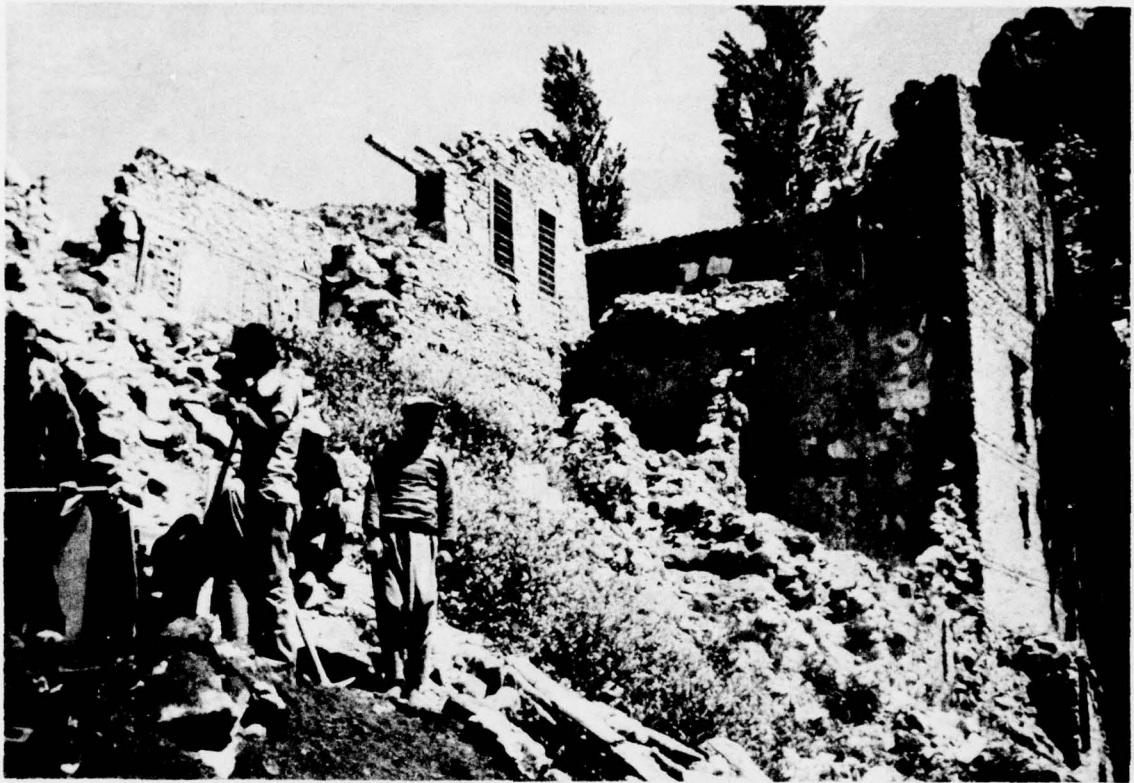
Figure A23. The terracing effect is clear in this picture. There were five levels of unreinforced and poorly connected adobe material in this building.

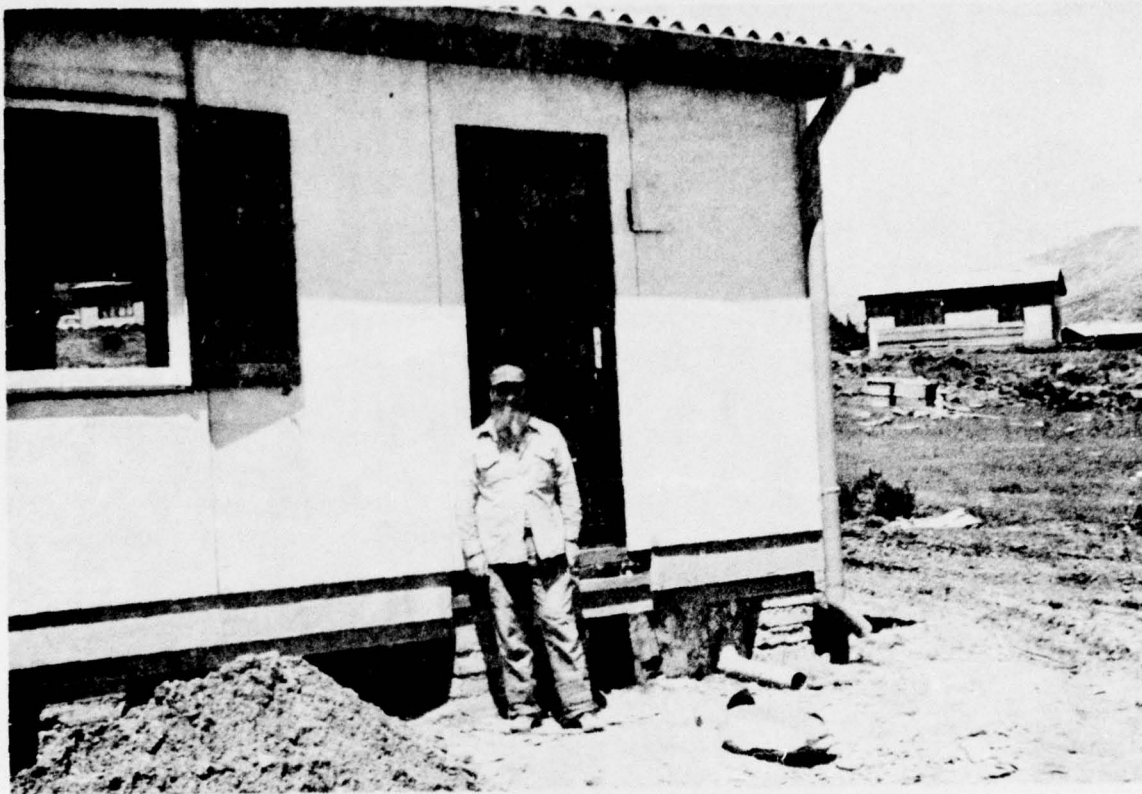
Figure A37. German style construction near Kulp.  
As with most new houses, there are no  
operational facilities for toilet or  
kitchen drainage.
